FORM B – BUILDING

Town: Reading

Address: 8 Copeland Avenue

Historic Name: Alfred & Grace Maggi House

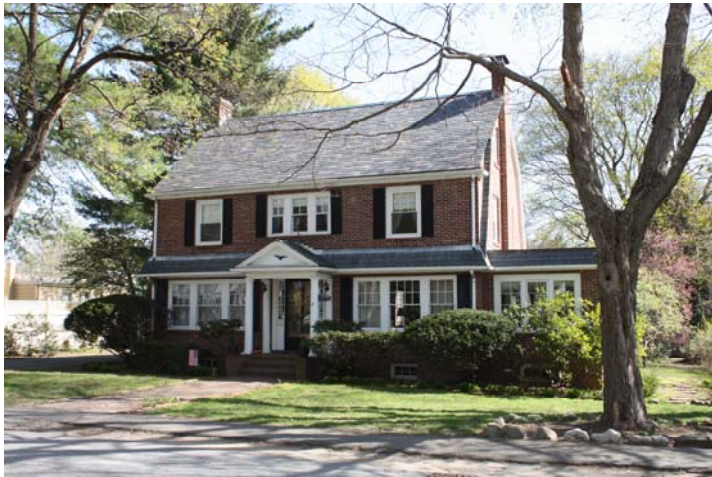
Photograph

Condition: good

The house at 8 Copeland Avenue is a good example of the Dutch Colonial style which found great popularity nationwide in the 1920s and 1930s. As is seen in this brick version which is notable for retaining its slate roof, the two-story structure displays gambrel ends with long shed dormers spanning the front and rear roof slopes. Exterior brick chimneys are centered on each of the gambrel ends. Centered on the three-bay façade is a pedimented entrance porch supported by Doric columns. The main entrance is flanked by partial sidelights and on either side of the entrance porch is a set of three 6/1 windows. The second floor façade windows also have multiple panes of glass in the upper sash and a single light sash below – a set of three 4/1 windows at the center and a 6/1 on either end of the dormer. Projecting from the south end of the house is a single-story, flat-roofed sunroom. To the northeast of the house is a brick garage capped by a gable, slate roof with two overhead garage doors facing the street.

The use of brick on Dutch Colonial houses is somewhat less typical – clapboards or wood shingles were the dominant exterior cladding. Another interesting example of a brick Dutch Colonial dwelling in Reading is visible at 98 Howard Street.
