FORM B – BUILDING

Town: Reading

Address: 75 Cross Street

Historic Name: Walter A. Ainsworth Rental Property

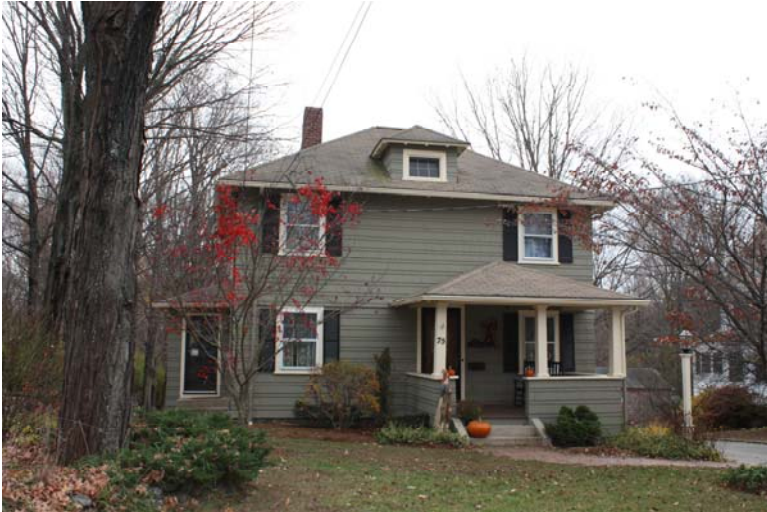
Photograph

Condition: good

An interesting variation on the Four Square house form, 75 Cross Street is a two-story dwelling with a boxy plan, capped by a low pitch hip roof with exposed rafter tails and a matching hip dormer centered on the roof slope. Among the unusual features is the wood shingle pattern which in which a double course of shingles is used with an overhang of just an inch or two at the bottom. The offcenter front porch also deviates from the typical porch which extends across the entire façade. In this case the porch shelters the offcenter entrance and one window. The hip roof of the porch is supported by squat posts resting on a shingled wall. The second floor of the façade is punctuated by two 6/1 windows at the outside edges of the elevation and aligned with those on the first floor; there is no window over the entrance. A small secondary entrance porch is located on the east elevation.
